**Operational Report: 4700 Cherryhill Rd. (Home Depot)
7 May 2006
Company 11's Area
Chief 11A-Bailey with the "Cherryhill Command"**

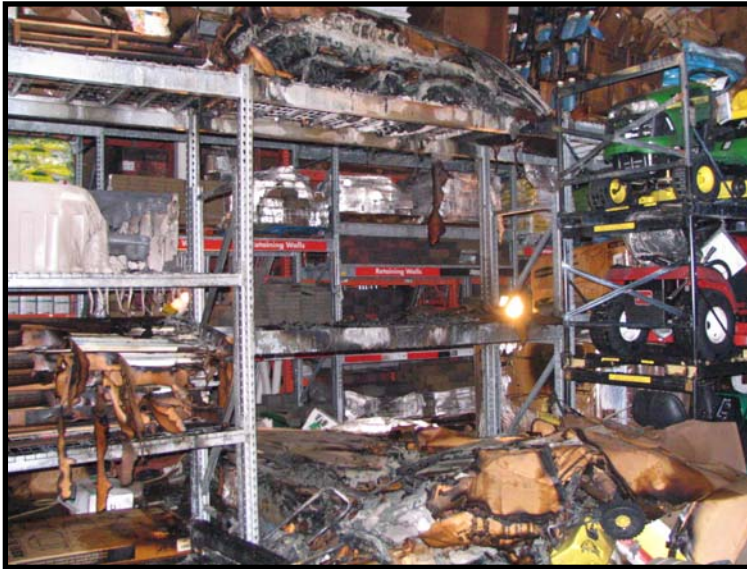
Safety Concerns: High Rack Storage and Toxic Combustion By-Products.

This fire was in the garden center of a Home Depot. The storage racks were extremely high. Also most of the merchandise was wrapped either in plastic wrap or in cardboard boxes, both of which suffered immediate degradation when exposed to the high levels of heat that were present.

types of storage, particularly in the rear of department stores. Command considered falling debris or rack collapse as the primary safety concern. Unit leaders and group/division supervisors must continuously re-evaluate the risk-benefit analysis when dealing with these hazards.

The second, but equally as deadly, concern was the type of material that was burning. Tonight luck was on the side of the fire department and only plastics and Class A materiel was on fire. However, fertilizers, oxidizers, and other hazardous storage were only one rack away. Again, the SCBA is the best tool we have and there is every indication that all members used their SCBA for the duration of the incident. It is likely that many know carcinogens were present in that smoke.

It is absolutely critical for all members to be cognizant of high rack storage hazards. This can be found in many
